Microscopy and archival research:

interpreting results within the context of historical records and traditional practice

Jane Davies

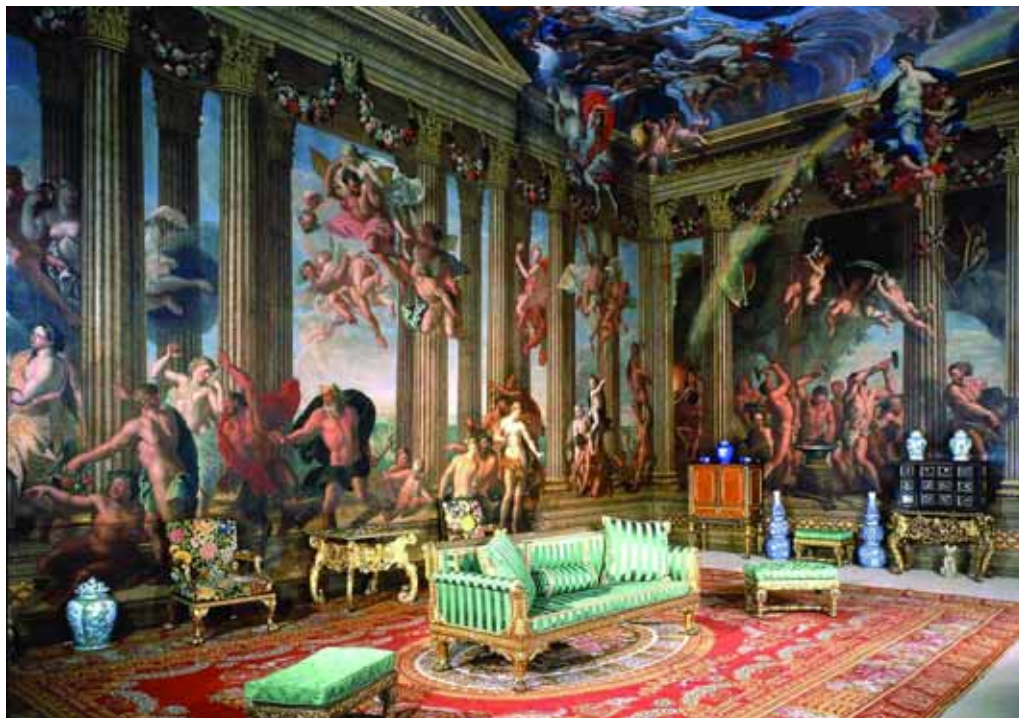
Fig. 1. The Heaven Room, Burghley House, painted by Antonio Verrio between 1694 and 1696. © Burghley House, Lincolnshire

In Burghley House, Lincolnshire, there survives a remarkable sequence of rooms painted by the Italian artist, Antonio Verrio. Verrio is credited with bringing the Baroque mural style from Italy, via the French Court of Louis XIV, to England and he became the premier artist of this genre. His rich ebullient work reflects the celebratory mood prevalent among English aristocrats during the Restoration period, and the Baroque style of decorating grand interiors became highly fashionable from the 1660s until the first quarter of the 18th Century. During the 1690s Verrio was working extensively for the 5th Earl of Exeter at Burghley House and between 1694 and 1696 he decorated the magnificent Heaven Room with images of 'Neptune and his Court', an 'Assembly of the Gods', 'Venus caught in Vulcan's net' and 'Cyclops forge' complete with a self portrait.

tasks such as flower painting and gilding. The splendid Heaven Room paintings have remained in very reasonable condition, with only one recorded historic intervention by the painter Thomas Stothard who carried out some restoration during 1801. They have recently been conserved by Mike Cowell. The Verrio Burghley archive is a very rich source of information on painting materials, including lists of binding oils, brushes, 'pencils' and

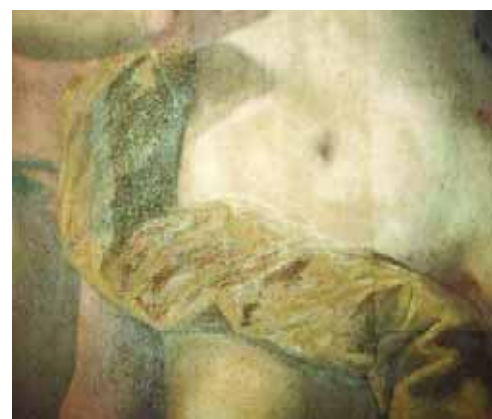
Fig. 2. Detail of Venus in the Heaven Room showing horizontal and vertical pentimenti from underlying architectural elements together with disfiguring delamination and cupping of specific areas of painted drapery overlying the architectural elements.

'architectural' paint layers in cross-sections and by examination in situ of raised outlines of pillars, pavements and lintels in raking light beneath overlying figure painting and occasional pentimenti, that Baroque muralists relied on the completion of a painted architectural 'stage', which became a framework for the figurative 'history' work. Interestingly, contemporary writing by the author Dudley Ryder, who visited Thornhill (a later rival of Verrio) whilst he was engaged in painting the interior of the Dome of St Paul's Cathedral, corroborates visual and analytical evidence. Ryder noted that the trompe l'oeil architecture was finished, the gilding partially done, but that none of the 'history part' had been painted.

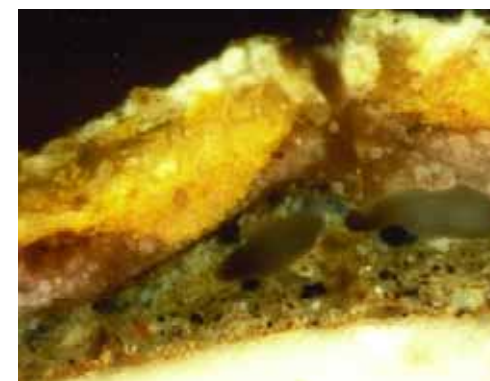
Fig. 3. Photomicrograph showing a sample from the less cracked drapery in cross-section. Photographed in dark field reflected light at 200x magnification. The sample illustrates the separation of the upper paint layers from the lower paint layers. The bright yellow is orpiment.

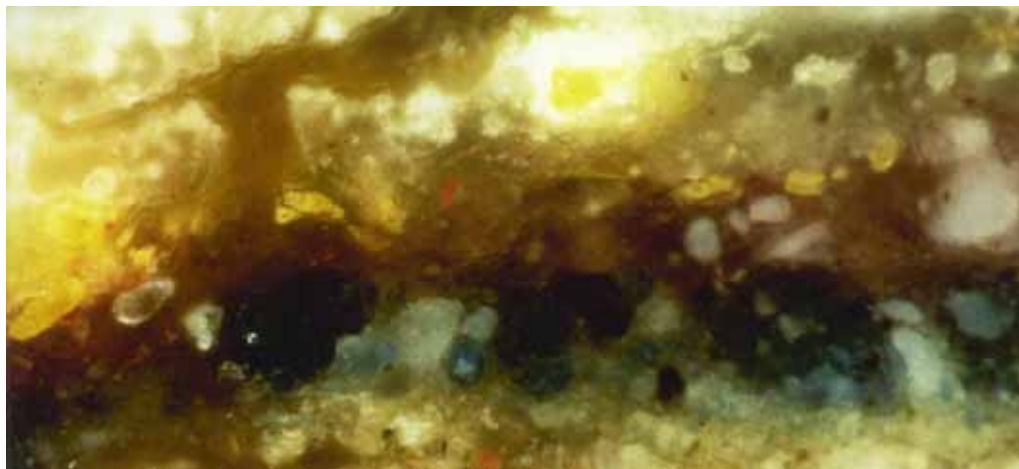
Fig. 4. Photomicrograph showing a sample from the cracked drapery in cross-section. Photographed in dark field reflected light at 200x magnification. The sample illustrates deterioration of the upper paint layer; it appears the yellow orpiment is undergoing alteration to white arsenic trioxide. Red lake and natural azurite pigments can be seen in the paint layers below the orpiment layer.

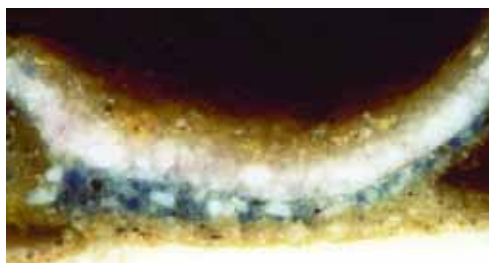
Fig. 5. Photomicrograph showing a sample from the cracked drapery in cross-section. Photographed in dark field reflected light at 200x magnification. The sample illustrates the separation of the upper paint layers from the lower paint layers. Thomas Stothard's varnish can be seen both on the surface and surrounding the edges of the paint flake.

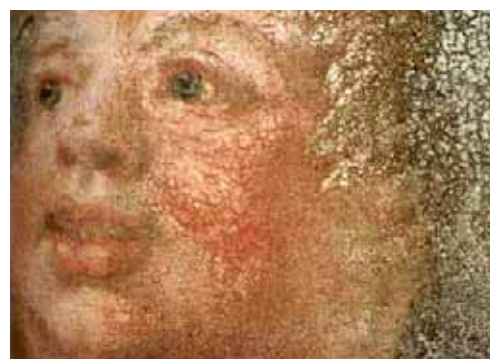
Fig. 6. Detail of Bacchus's head in the Heaven Room showing the disfiguring 'alligator' craquelure which appears on many baroque murals and appears to be associated with aspects of original technique, in particular the sequential application of numerous paint layers representing trompe l'oeil architecture. The left side (as seen) of Bacchus is sound, whilst the right is damaged. Dark areas have noticeably more severe craquelure, and it is probable that more than one phenomenon is affecting the paint in this area.

At Burghley, as well as identification of the constituent materials, a further aim of research was to investigate the cause of the disturbing cupping and disruption of the paint — a defect which appears on many Baroque murals is a distracting 'alligator' craquelure. The craquelure has an appearance which is generally associated with poor drying of an oil medium, where the upper paint surface has contracted to form a series of scales. However in the paintings studied, this drying cracking appears to be associated as much with the number of underlying layers of ground, architecture etc. as with an inherent fault in the paint mixtures. The number of layers present appears to relate to 'studio' practice as discussed above.

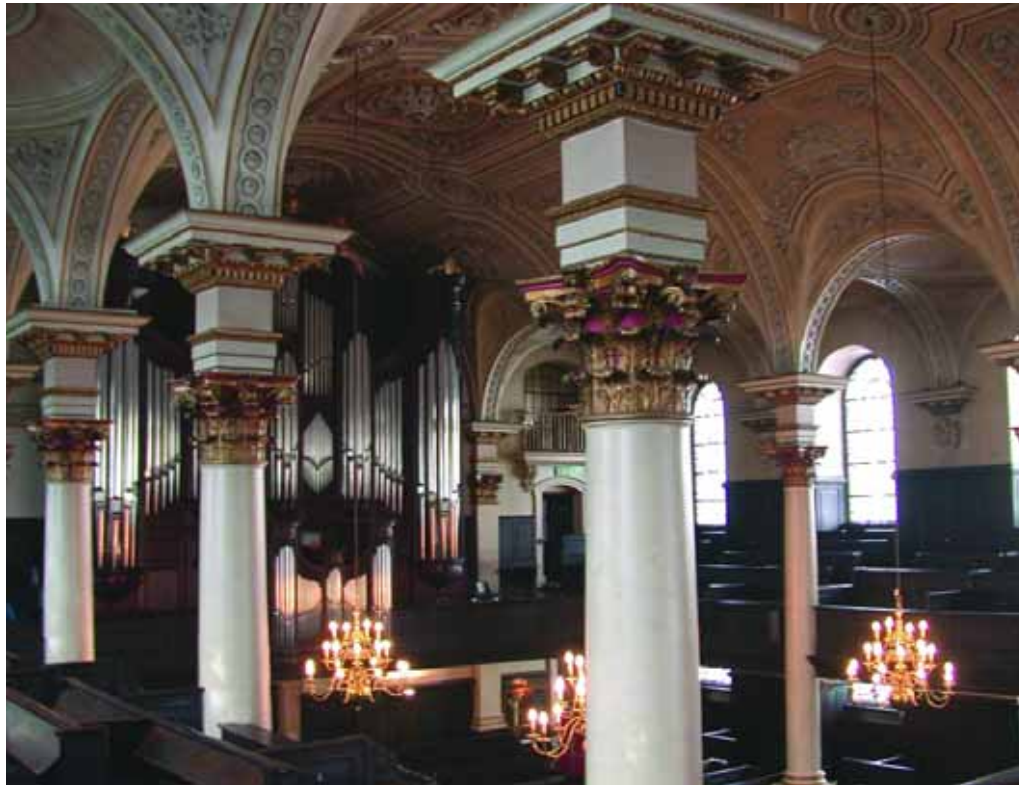
Fig. 8. St Martin-in-the-Fields Church, interior view looking west towards the organ.

body of the church only bore evidence from the mid 19th Century onwards. Why had the evidence of 18th Century paint in the Nave 'disappeared'? Enlightenment came from careful reading of the original accounts and a trip back to the church to measure the size of the Apse. Mr Stokes had only painted '345 1/2 yards... in oil' and this is the size of the Apse. The main body of the church would have been more cheaply decorated using soft distempers, a water washable finish traditionally removed each time a new redecoration is applied. Distempers were considered as part of the plasterer's work, not as a separate job for painters and therefore no original record survives for this decoration.

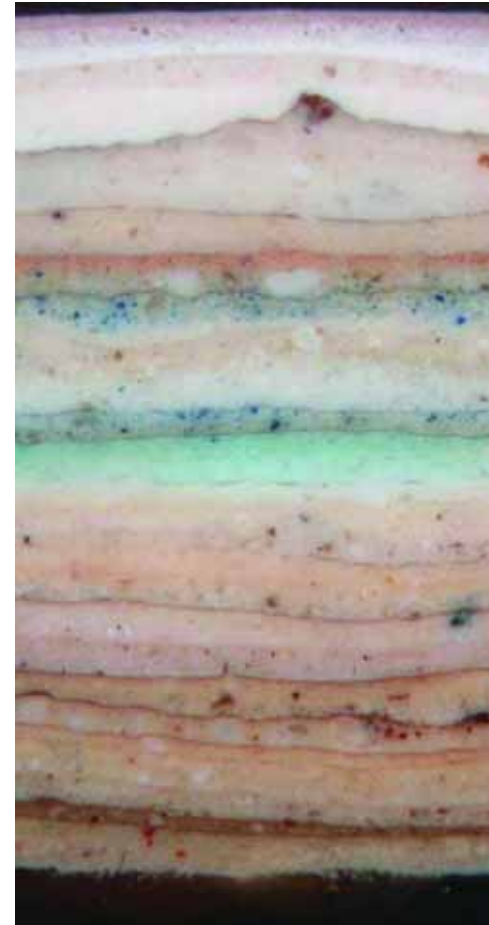
Fig. 9. St Martin-in-the-Fields Church, sample from the Apse which shows the early stone colours and the presence of a trace of distemper at the base of the sample. Distemper is a soft porous paint composed of chalk bound in animal glue and coloured with pigments. It is a relatively soft finish and remains resolvable in warm water and was commonly removed prior to redecoration. Always applied over fresh lime plaster to allow the plaster to carbonate, harden and dry out fully. Photographed in dark field reflected light at 200x magnification.

Interestingly the original decoration reflects the liturgical hierarchy of the internal spaces in the expense, number and type of paint finishes applied. From construction until the late 19th Century the Apse was the focus of the interior decoration. On paint samples from the Apse evidence of the temporary 'Builder's finish' distemper is present, swiftly followed by the first decoration employing oil bound paints, which was present upon consecration of the church. The analysis of paint samples bears mute witness to the accuracy of the archive records, as physical evidence from the paint samples tallies with the descriptions of painting recorded in the archived bills. The original decorative scheme presented the Apse, coated four times with oil

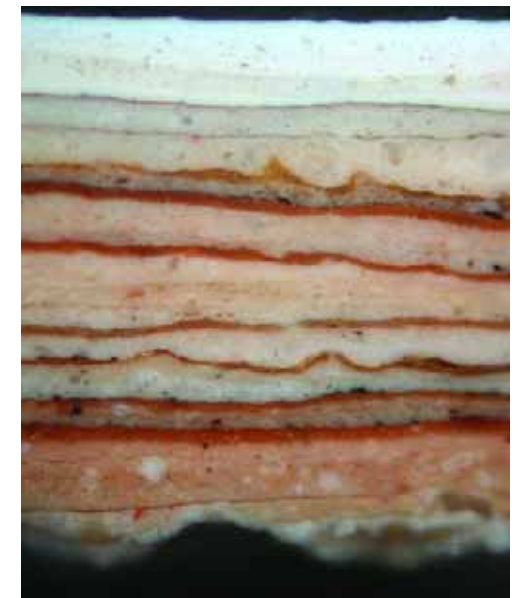
Fig. 10. St Martin-in-the-Fields Church, sample from the Apse, which shows the original gilding overlying the original paint scheme of four layers of stone colour paint. A further five gilding schemes are present, before the area is painted plain white, probably during the early 20th Century. Photographed in dark field reflected light at 200x magnification.

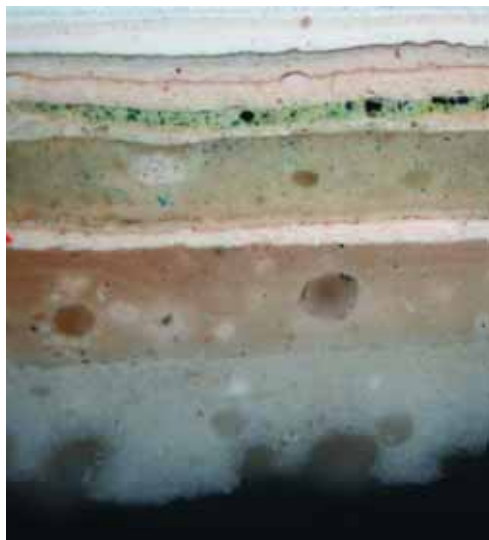
Fig. 11. St Martin-in-the-Fields Church, sample from the Nave ceiling, which shows the presence of later oil layers only. Earlier distempers survive, but only a few, which suggests they were washed off prior to redecoration, not that more distempers were never present. The distempers appear to date from the 19th Century. Photographed in dark field reflected light at 200x magnification.

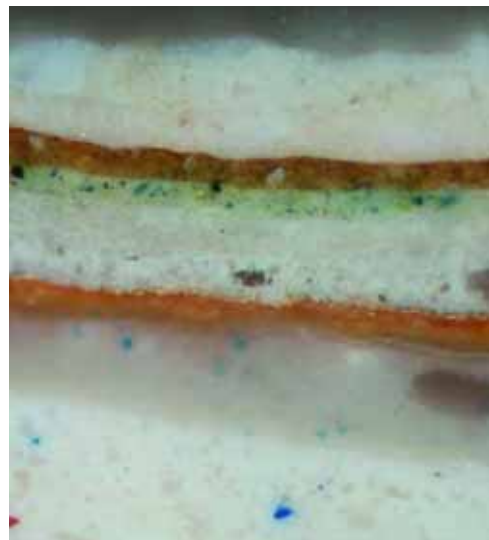
Fig. 12. St Martin-in-the-Fields Church, sample from the Nave ceiling, which shows the introduction of gilding to the main church ceiling in the mid 19th Century. The presence of French Ultramarine is considered sufficient to approximately date the scheme. The mixed green relates to the polychrome Harrod's decoration and contains Prussian Blue and Chrome yellow, a colour known as 'Brunswick Green'. Oil gilding is present on the surface of the Brunswick Green. Photographed in dark field reflected light at 200x magnification.

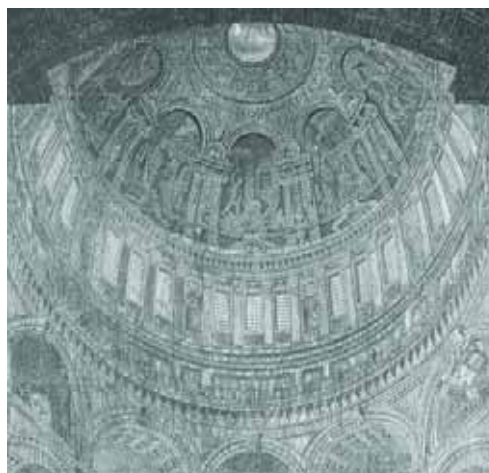
Fig. 13. An image of the interior of the dome of St Paul's Cathedral by the artist Coney, 1818, which shows trompe l'oeil painting on the Tambour and Whispering Gallery walls.

shows *trompe l'oeil* swags and crossed swords in the plain panels below the windows and larger figurative panels to the Whispering Gallery wall. Coney's 1818 engraving of the interior also shows large rectangular frames, presumed to be Thornhill's paintings, on the walls of the Whispering Gallery. A.W.N. Pugin's ink drawing of May 1828 indicates fictive panelling with crossed swords and swags below the windows, fluting to the faces of the columns and scalloping within the niche heads, however no panels to the Whispering Gallery walls.

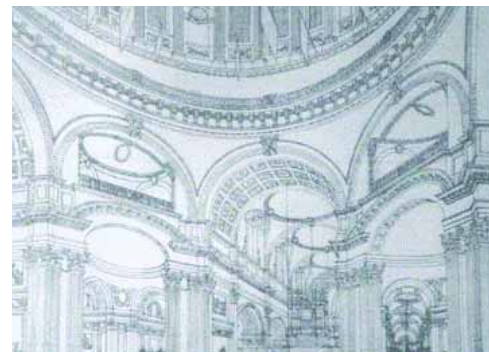
Fig. 14. Pugin's 19th Century image of the Dome of St Paul's Cathedral showing trompe l'oeil painting to the Tambour.

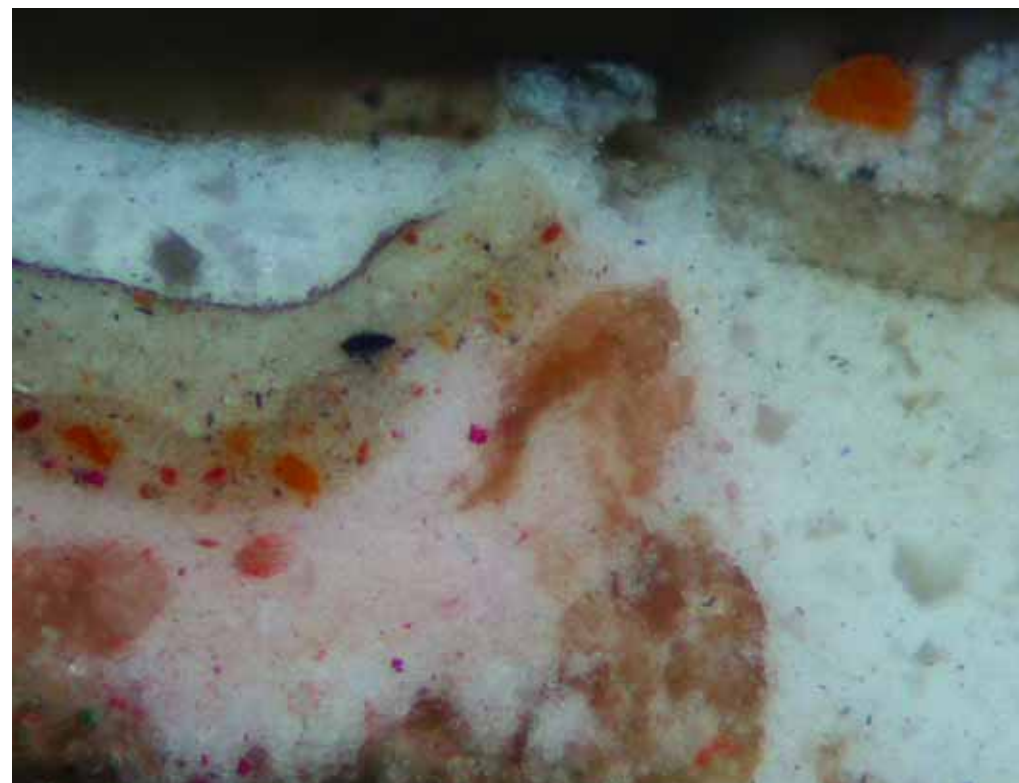
Fig. 15. St Paul's Cathedral, sample from the Whispering Gallery walls showing the original Thornhill decoration to the left and 19th Century overpaint to the right. The 19th Century overpaint fills a loss in the Thornhill paint. Later overpaint is present on the surface of the sample. Photographed in dark field reflected light at 200x magnification.

The Whispering Gallery walls were overpainted at some time during the 19th Century: the presence of barytes in the first overpaint confirms this approximate dating. Archive sources suggest that in 1856 the paintings of the Tambour were still extant as the Trustees considered *'the repairs of paintings in the drum... [for] £800'* but decided not to proceed and to reconsider at some future date. In 1860 the Chapter Minutes, St Paul's Library, record that the *'cost of re-gilding and cleaning the walls of the Drum has been provided for by the St Paul's Cathedral Fund'*. It seems probable that the reference to cleaning is rather euphemistic and would be more accurately understood to mean overpainting of the *trompe l'oeil* design. It is clear from examination of the samples that the condition of the Thornhill decoration was probably fairly poor when it was obliterated by application of a thick off-white overpaint. Paint samples reveal that the Thornhill painting had suffered from cracking, delamination (at the interface of the substrate and preparatory paint layers) and subsequent loss.

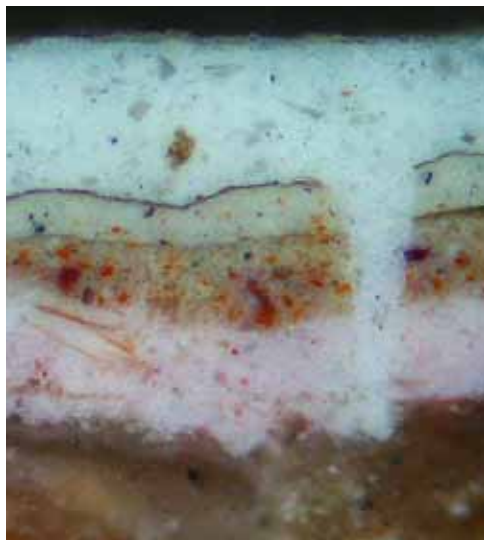
Fig. 16. St Paul's Cathedral, sample from the Whispering Gallery walls showing the original Thornhill decoration which a dark line of surface dirt marking the upper boundary of the original pale stone paint. The Thornhill paint has developed a deep vertical crack which has subsequently been filled by 19th Century overpaint. Photographed in dark field reflected light at 200x magnification.

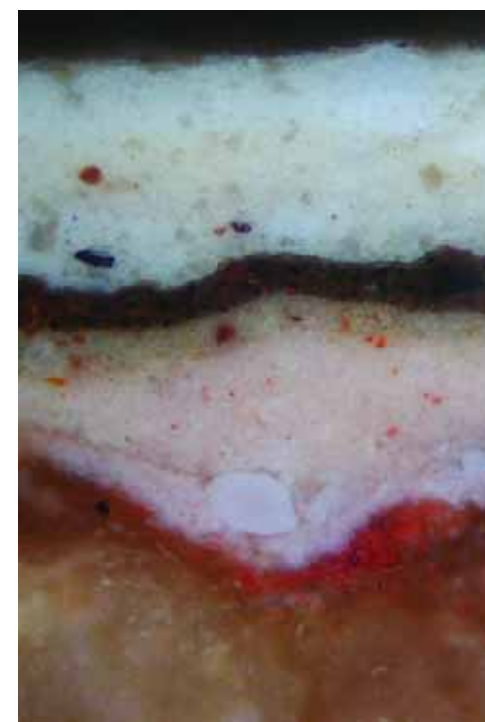
Fig. 17. St Paul's Cathedral, sample from the Whispering Gallery walls, which shows the original Thornhill decoration with a dark surface paint. When the Thornhill painting was visible this area would have represented a shadow. Photographed in dark field reflected light at 200x magnification.

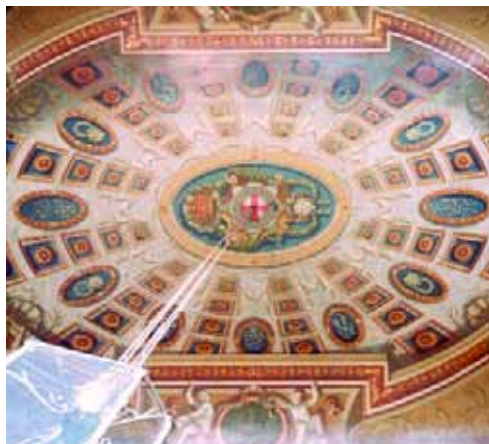
Fig. 18. General view of the ceiling of the Queen's Staircase, Hampton Court Palace. The image was made as part of a rectified photography survey and has a pair of superimposed fine cross-hairs which are not part of the painted image. © Crown copyright: Historic Royal Palaces

The Queen's staircase was painted in a consummately skilful and direct style using oil bound pigments and gilding on a lime plaster and riven oak lath support. The artist's preparation for painting comprises a considerable build-up of a red sealant layer together with a triple ground, applied in three separate layers. Over the preparation the design was created from a relatively simple application of paints, generally as opaque layers, with translucent paint glazes used to add depth, colour and richness to the design. Techniques for laying out of the design, such as pencil marks, incisions in wet paint and pouncing (carbon tracing) marks are present.

The presence of a friable chalk layer between the plaster support and the painting appears likely to be the cause of delamination and flaking. Comparable samples of Kent's painted State Bedroom ceiling at Houghton Hall, Norfolk, do not bear the same chalk layer below the sealant. The origin of the chalk layer on the ceiling of the Queen's staircase may never be known with absolute certainty. However, it seems possible that it is present due to an oversight by Kent, in omitting to remove an earlier plasterer's water-based paint, rather than as a deliberately planned application by Kent and his assistants. It was common practice for fresh lime plasters to be 'finished' with a porous water-based paint, whilst the

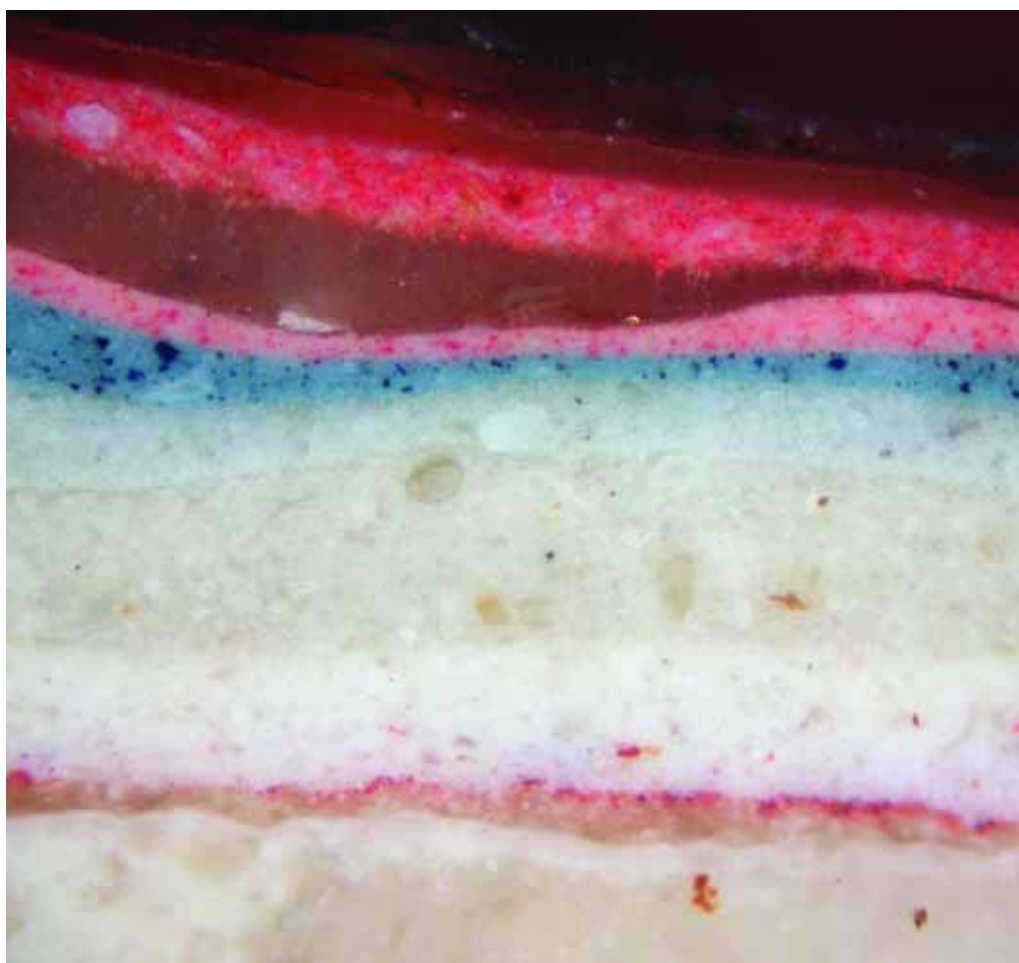
Fig. 19. Queen's Staircase, Hampton Court, sample from the central area of the ceiling, background to the garter star. The sample shows the build up of Kent's preparatory and paint layers, with red sealant applied over a translucent chalk layer which sits directly on the plaster surface. Photographed in dark field reflected light at 200x magnification.

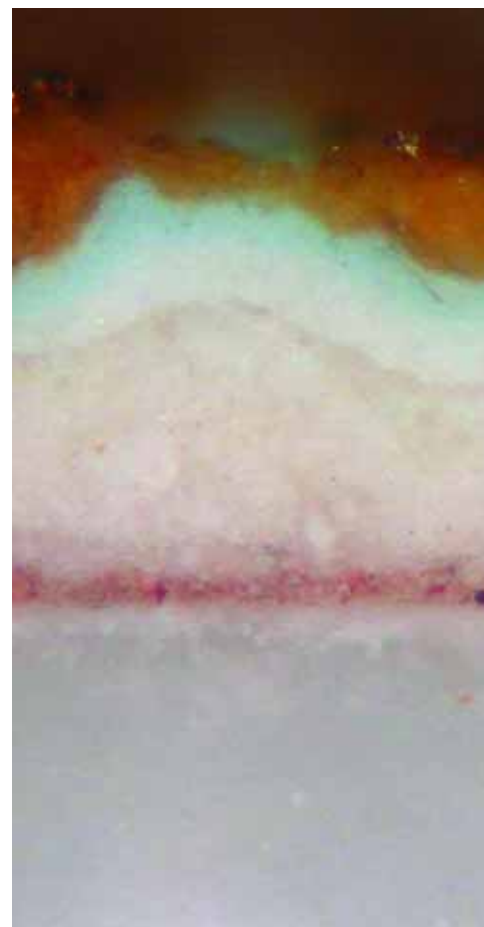
Fig. 20. Houghton Hall, Norfolk, sample from the ceiling of the Embroidered bedroom. The sample shows Kent's preparatory and paint layers which the typical red sealant applied directly to the plaster surface. Photographed in dark field reflected light at 200x magnification.
