Shot to pieces and shocked to the core

Lisa Mol and Owen Green

Bullet impacts are an often overlooked mechanism of stone decay. High speed impacts cause fracture networks that alter the stone matrix. Here we report on initial findings of a microscopical investigation into fracture networks and their responses to environmental change.

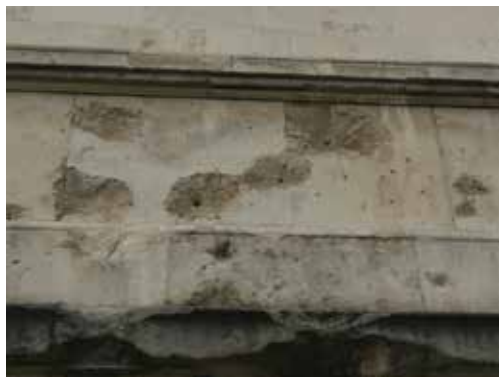
Figure 1: Close up of Tate Britain in London, exhibiting damage from WWII

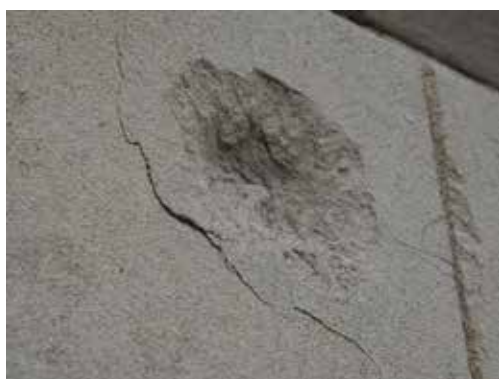
Figure 3: Close-up of WWII bullet impact on the Main Building, Cardiff University, illustrating the complex interaction of the direct impact zone and the fracturing of the surrounding stone

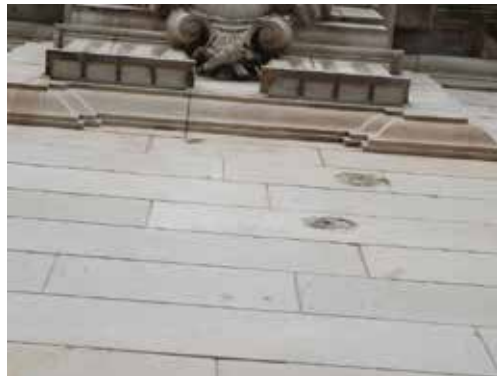
Figure 2: Close up of Cardiff University Main Building façade with air-raid damage inflicted during WWII

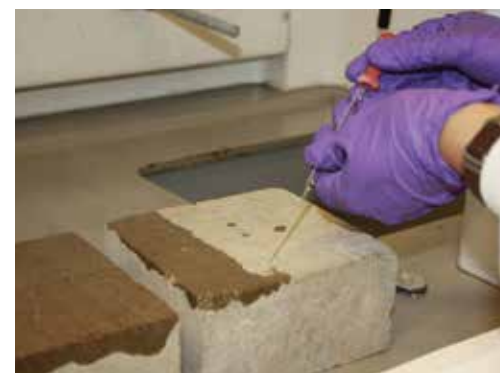
Figure 5: Application of the Wacker treatment

The consolidant Wacker SILRES BS OH100 was applied to half the samples, as a means of mimicking a hardened weathered surface crust, which is frequently seen on freshly cut building stone exposed to the natural elements.

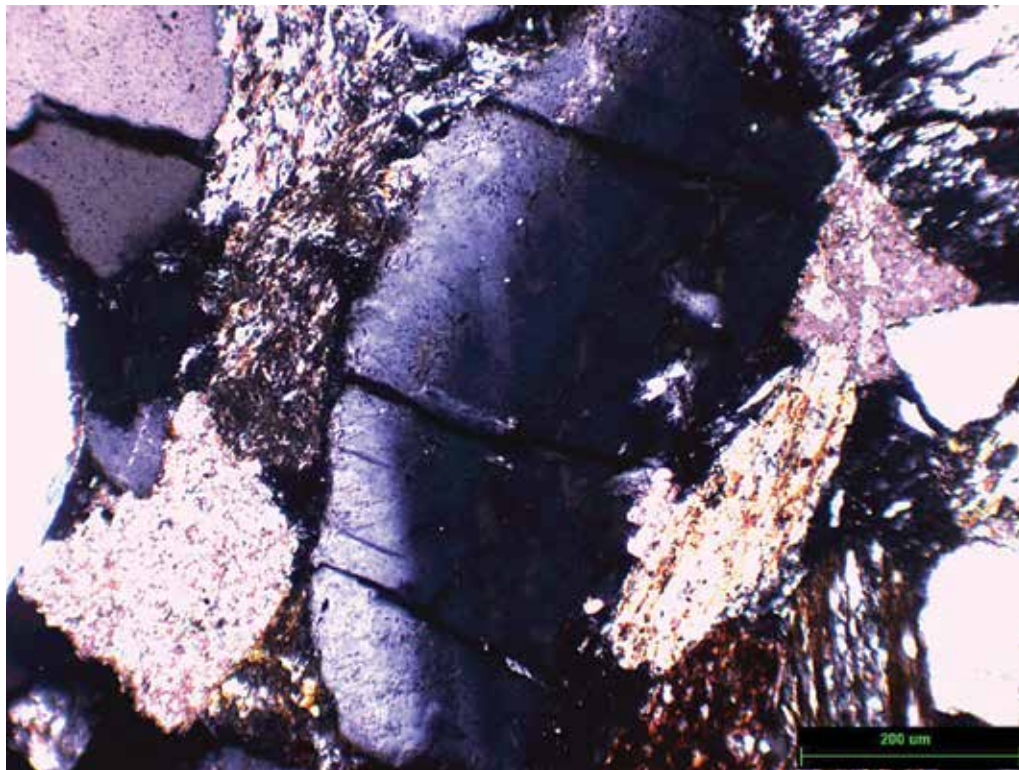
Figure 14: Sample 3, example of grain bruising and parallel fracture networks which were observed in sample 3 around the zone of impact

This sample also exhibits 'bruising' where part of the grain appears to have been reduced in refractive index (also noted by Fratanduono *et al* (2011) in shocked quartz), resulting partial discolouration as observed using cross-polarised light. This discolouration was not observed in grains outside of the direct impact area, indicating that this 'bruising' is closely connected to the shock generated on impact.

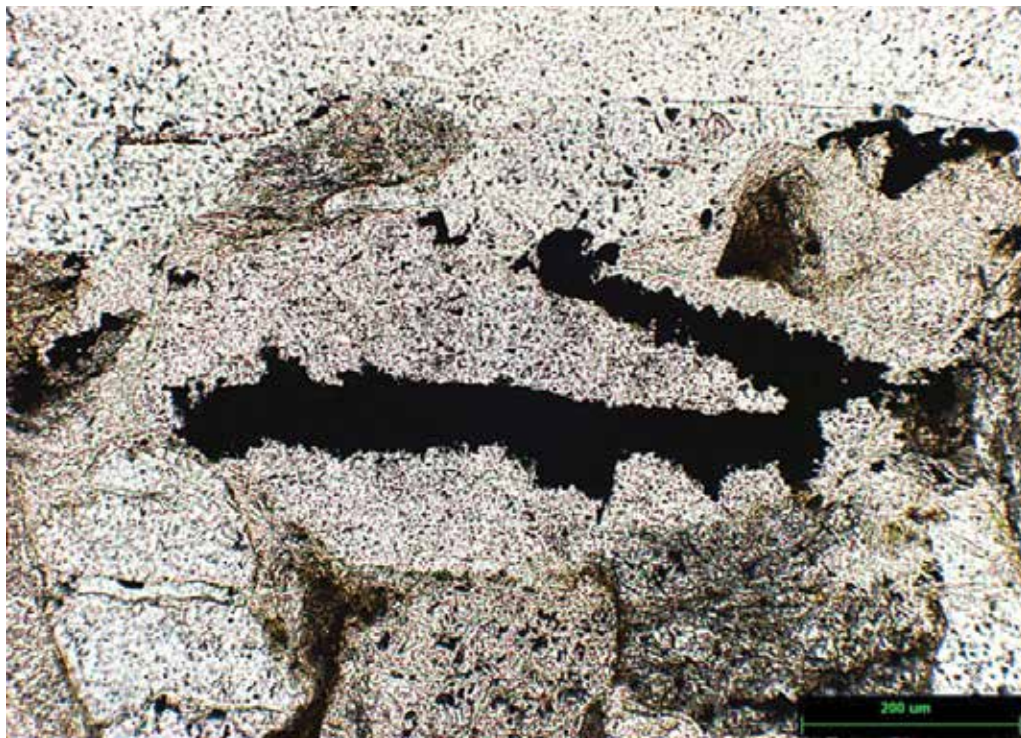
Figure 19: Close up of the centre section of the lead intrusions into the surface of sample 7 where the lead intrusion has taken advantage of a pre-existing weakness in the grain and has fractured the grain, intruding not only through the centre but also into crevices extending from the centre fracture
